**Flood Control Project Maintenance
Levee Inspections**

Maintenance Issue Types Only, Levee Inspection Report By Mile - Spring 2019

Reclamation District No. 0070 Meridian

Waterway	Bank	Unit Miles	Inspection Start/End	Inspector
Unit No. 01 Sutter Bypass	Right	7.92	04/02/2019 04/02/2019	Makar Sokol

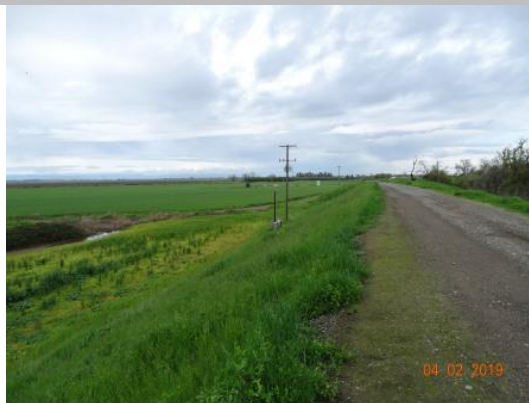
Photo 1 of 1 : SP_2019_RD0070_29_2_20190405_00073.jpg

LM Start	0.01	Rating **	M	Issue No.	2
LM End	7.90	Issue Type +	Ma	Location *	LS
Category	Earthen Levee			GPS Latitude/Longitude	
				Start	End
Item	Vegetation			39.137184 °	39.194261 °
				-121.834630 °	-121.935328 °
DWR ID	DWR_RD0070_01_s_2012_2				
Comment Code					
V1 : Control annual grass and weeds on the levee slopes and easements.					
Inspector Comment

View of the vegetation along the landside slope. Spring 2019.

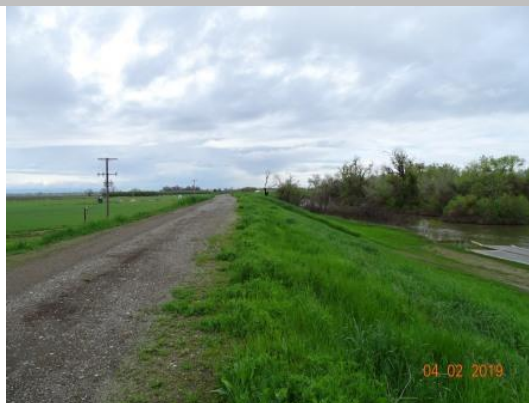
Photo 1 of 1 : SP_2019_RD0070_29_5_20190405_00072.jpg

LM Start	0.01	Rating **	M	Issue No.	5
LM End	7.90	Issue Type +	Ma	Location *	WS
Category	Earthen Levee			GPS Latitude/Longitude	
				Start	End
Item	Vegetation			39.137184 °	39.194261 °
				-121.834630 °	-121.935328 °
DWR ID	DWR_RD0070_01_s_2012_5				
Comment Code					
V1 : Control annual grass and weeds on the levee slopes and easements.					
Inspector Comment

View of the vegetation along the waterside slope. Spring 2019.

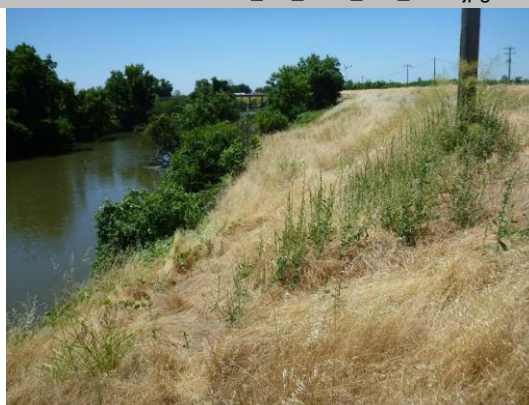
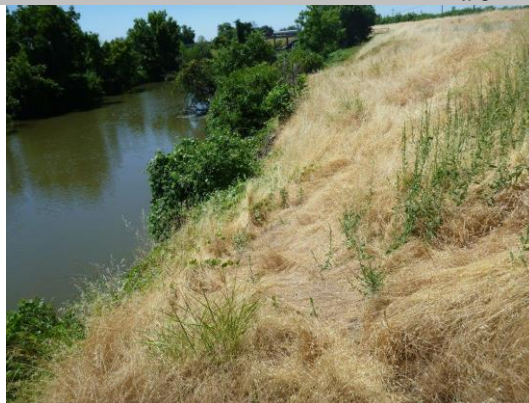
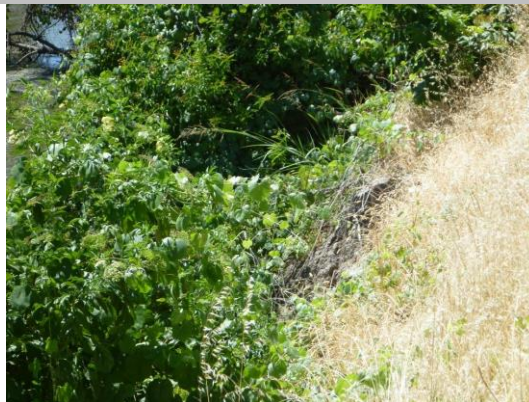
LM Start	0.76	Rating **	A/W	Issue No.	36
LM End	0.76	Issue Type +	Ma	Location *	WS
Category	Supplemental		GPS Latitude/Longitude		
			Start	End	
Item	2017 Storm Damage		39.145240 °	39.145240 °	
			-121.842650 °	-121.842650 °	
DWR ID	DWR_RD0070_01_f_2017_36				
Comment Code					
Inspector Comment					
Levee Evaluation Comments					
Description:					
Site ID No:154					
Site Designation:RD 70-03					
Repair Type: Erosion					
Rating:Area of Concern					
Field Date:7/17/2017					
Notes:

LM Start	0.76	Rating **	A/W	Issue No.	36 (cont)	
LM End	0.76	Issue Type +	Ma	Location *	WS	
Category	Supplemental			GPS Latitude/Longitude		
				Start	End	
Item	2017 Storm Damage			39.145240 °	39.145240 °	
				-121.842650 °	-121.842650 °	
DWR ID	DWR_RD0070_01_f_2017_36					
Comment Code						
Inspector Comment						
Levee Evaluation Comments						
Description:						
Site ID No:154						
Site Designation:RD 70-03						
Repair Type: Erosion						
Rating:Area of Concern						
Field Date:7/17/2017						
Notes:

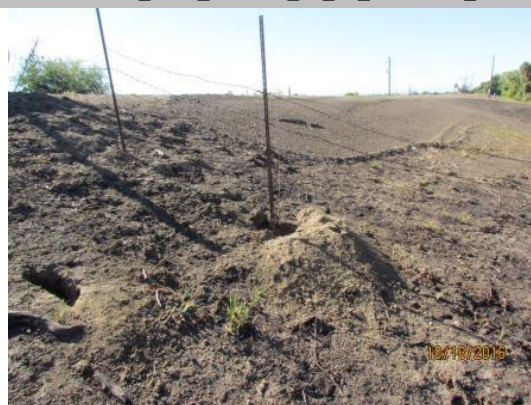
Photo 1 of 1 : SP_2019_RD0070_29_32_20190326_00007.jpg

LM Start	1.77	Rating **	M	Issue No.	32
LM End	1.77	Issue Type +	Ma	Location *	WS
Category	Earthen Levee			GPS Latitude/Longitude	
				Start	End
Item	Animal Control			39.151282 °	39.151282 °
				-121.855818 °	-121.855818 °
DWR ID	DWR_RD0070_01_f_2016_32				
Comment Code					
A1 : Exterminate rodents and backfill and compact or grout burrows.					
Inspector Comment

View of the rodent holes along the waterside slope.

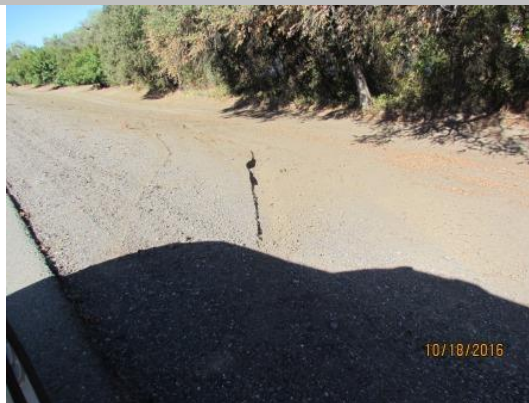
Photo 1 of 1 : SP_2019_RD0070_29_29_20190326_00004.jpg

LM Start	3.72	Rating **	M	Issue No.	29
LM End	3.72	Issue Type +	Ma	Location *	WS
Category	Earthen Levee			GPS Latitude/Longitude	
				Start	End
Item	Slope Stability			39.158183 °	39.158183 °
				-121.888397 °	-121.888397 °
DWR ID	DWR_RD0070_01_f_2016_29				
Comment Code					
S3 : Repair the levee slope damaged by vehicle traffic and prevent access where possible.					
Inspector Comment

View of the ruts along the waterside slope.

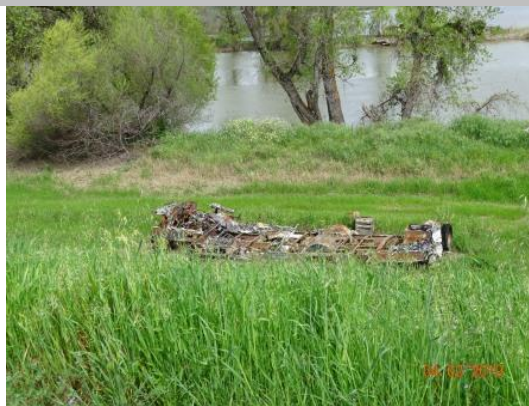
Photo 1 of 1 : SP_2019_RD0070_29_42_20190405_00074.jpg

LM Start	4.21	Rating **	M	Issue No.	42
LM End	4.21	Issue Type +	Ma	Location *	WS
Category	Earthen Levee			GPS Latitude/Longitude	
				Start	End
Item	Encroachments			39.163280 °	39.163280 °
				-121.894480 °	-121.894480 °
DWR ID	DWR_RD0070_01_s_2019_42				
Comment Code					
DE : Debris					
Inspector Comment					
The pile of debris should be removed from waterside toe.

View of the debris on the waterside slope.

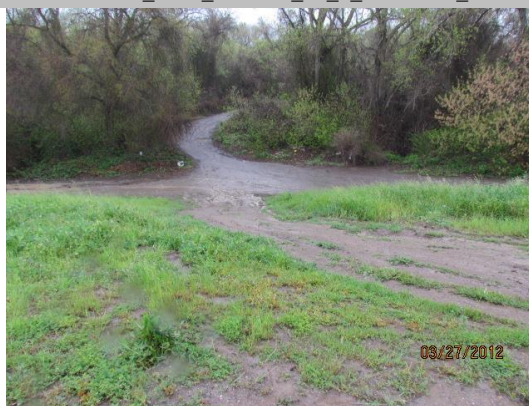
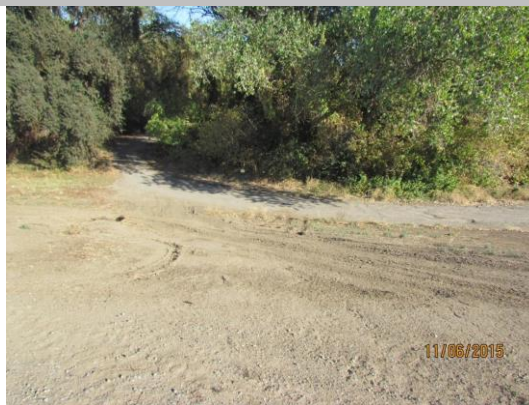
LM Start	6.18	Rating **	M	Issue No.	6
LM End	6.18	Issue Type +	Ma	Location *	WS
Category	Earthen Levee			GPS Latitude/Longitude	
				Start	End
Item	Slope Stability			39.187481 °	39.187481 °
				-121.910852 °	-121.910852 °
DWR ID	DWR_RD0070_01_s_2012_6				
Comment Code					
S3 : Repair the levee slope damaged by vehicle traffic and prevent access where possible.					
Inspector Comment

View of vehicle erosion along the waterside slope.

View of the vehicle erosion along the waterside slope.

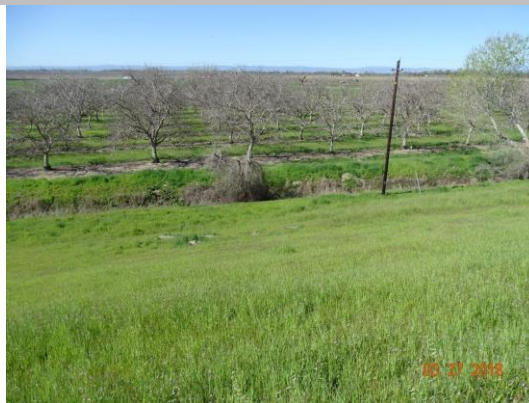
Photo 1 of 1 : SP_2019_RD0070_29_35_20190326_00009.jpg

LM Start	6.44	Rating **	M	Issue No.	35
LM End	6.44	Issue Type +	Ma	Location *	LS
Category	Earthen Levee			GPS Latitude/Longitude	
				Start	End
Item	Animal Control			39.190897 °	39.190897 °
				-121.912713 °	-121.912713 °
DWR ID	DWR_RD0070_01_s_2018_35				
Comment Code					
A3 : No rodents visible, but rodent burrows visible; need to backfill and compact or grout burrows.					
Inspector Comment

View of the rodent holes along the landside slope.

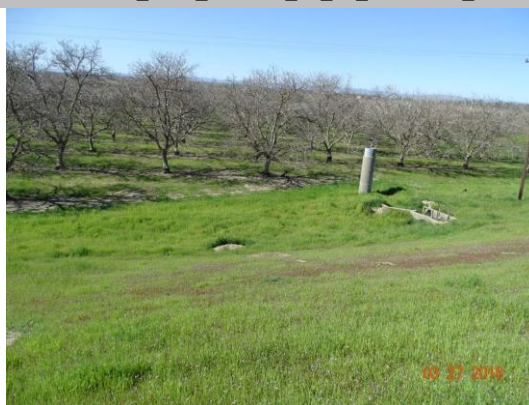
Photo 1 of 1 : SP_2019_RD0070_29_40_20190326_00018.jpg

LM Start	6.57	Rating **	U	Issue No.	40
LM End	6.57	Issue Type +	Ma	Location *	LS
Category	Earthen Levee			GPS Latitude/Longitude	
				Start	End
Item	Animal Control			39.192283 °	39.192283 °
				-121.914388 °	-121.914388 °
DWR ID	DWR_RD0070_01_f_2018_40				
Comment Code					
A3 : No rodents visible, but rodent burrows visible; need to backfill and compact or grout burrows.					
Inspector Comment					
Several large rodent holes were observed in this area.

View of rodent holes along the landside slope.

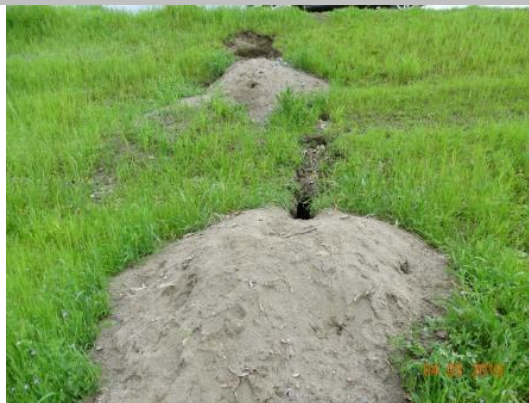
Photo 1 of 1 : SP_2019_RD0070_30_101_20190408_00140.jpg

LM Start	0.85	Rating **	U	Issue No.	101
LM End	0.85	Issue Type +	Ma	Location *	WS
Category	Earthen Levee			GPS Latitude/Longitude	
				Start	End
Item	Animal Control			39.185567 °	39.185567 °
				-121.941427 °	-121.941427 °
DWR ID	DWR_RD0070_02_s_2019_101				
Comment Code					
A3 : No rodents visible, but rodent burrows visible; need to backfill and compact or grout burrows.					
Inspector Comment

View of large rodent holes on the waterside slope. Spring 2019.

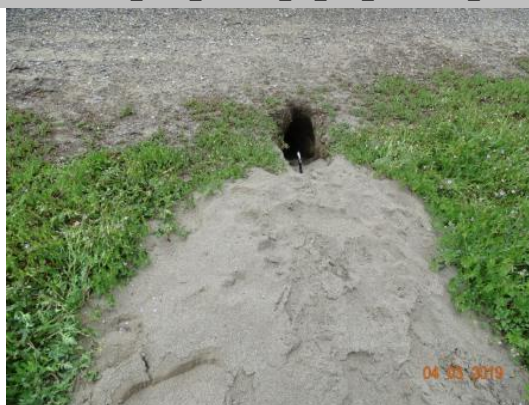
Photo 1 of 1 : SP_2019_RD0070_30_100_20190408_00139.jpg

LM Start	0.89	Rating **	U	Issue No.	100
LM End	0.89	Issue Type +	Ma	Location *	LS
Category	Earthen Levee			GPS Latitude/Longitude	
				Start	End
Item	Animal Control			39.185059 °	39.185059 °
				-121.941878 °	-121.941878 °
DWR ID	DWR_RD0070_02_s_2019_100				
Comment Code					
A3 : No rodents visible, but rodent burrows visible; need to backfill and compact or grout burrows.					
Inspector Comment

View of a large rodent burrow on the landside slope near the shoulder. Spring 2019.

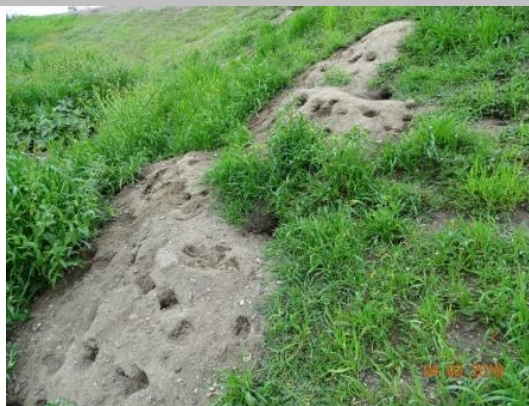
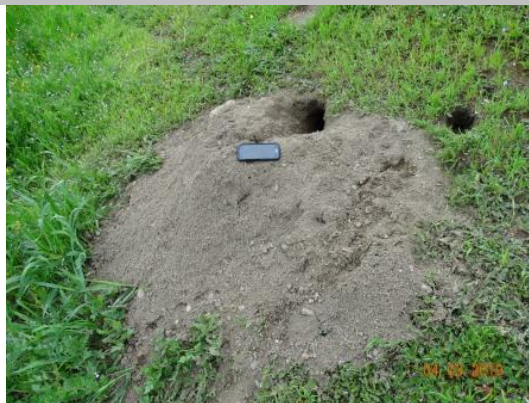
LM Start	2.03	Rating **	U	Issue No.	96
LM End	2.03	Issue Type +	Ma	Location *	LS
Category	Earthen Levee			GPS Latitude/Longitude	
				Start	End
Item	Animal Control			39.170526 °	39.170526 °
				-121.936880 °	-121.936880 °
DWR ID	DWR_RD0070_02_s_2019_96				
Comment Code					
A1 : Exterminate rodents and backfill and compact or grout burrows.					
Inspector Comment

View of the rodent activity on the landside slope. Spring 2019.

View of a large rodent burrow on the landside slope. Spring 2019.

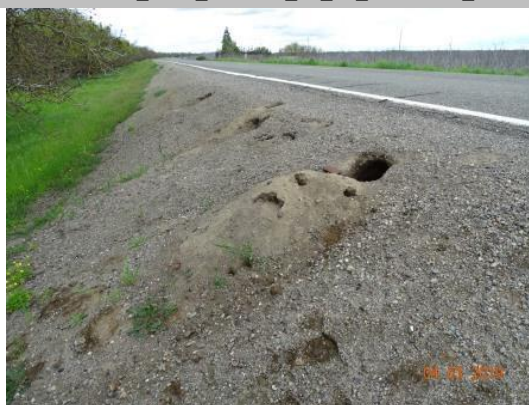
Photo 1 of 1 : SP_2019_RD0070_30_95_20190408_00135.jpg

LM Start	3.58	Rating **	U	Issue No.	95
LM End	3.58	Issue Type +	Ma	Location *	WS
Category	Earthen Levee			GPS Latitude/Longitude	
				Start	End
Item	Animal Control			39.154026 °	39.154026 °
				-121.920108 °	-121.920108 °
DWR ID	DWR_RD0070_02_s_2019_95				
Comment Code					
A3 : No rodents visible, but rodent burrows visible; need to backfill and compact or grout burrows.					
Inspector Comment

View of a large rodent burrow on the waterside slope/shoulder. Spring 2019.

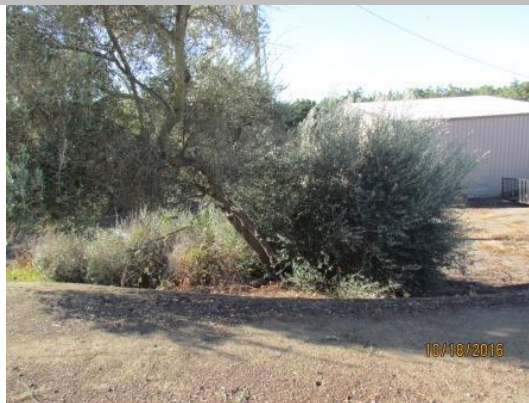
Photo 1 of 1 : SP_2019_RD0070_30_54_20190326_00005.jpg

LM Start	4.95	Rating **	M	Issue No.	54
LM End	4.95	Issue Type +	Ma	Location *	LS
Category	Earthen Levee			GPS Latitude/Longitude	
				Start	End
Item	Trim / Thin Trees			39.142016 °	39.142016 °
				-121.926214 °	-121.926214 °
DWR ID	DWR_RD0070_02_f_2016_54				
Comment Code					
T1 : Trim trees to at least five feet above ground level.					
Inspector Comment

View of the trees blocking visibility.

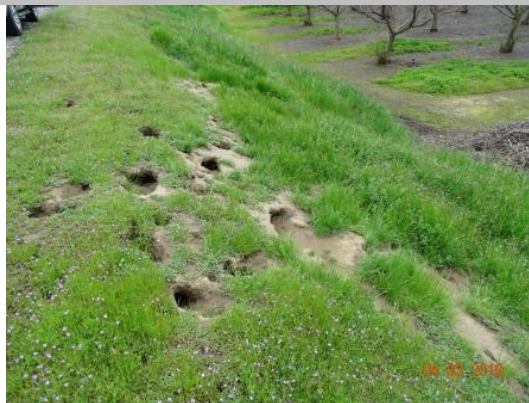
Photo 1 of 3 : SP_2019_RD0070_30_89_20190408_00129.jpg

View of the rodent burrows on the landside slope. Spring 2019.

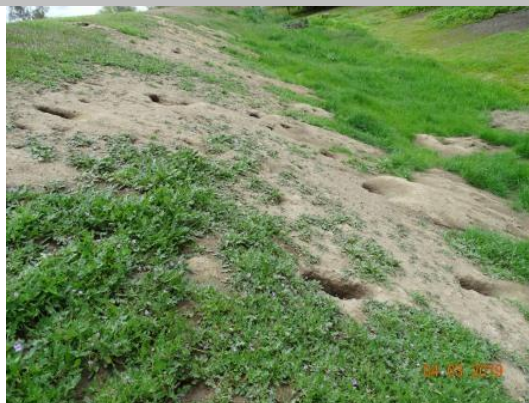
Photo 2 of 3 : SP_2019_RD0070_30_89_20190408_00130.jpg

Another view of the rodent burrows on the landside slope. Spring 2019.

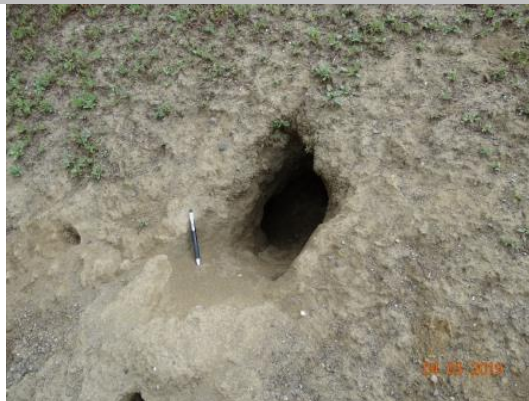
Photo 3 of 3 : SP_2019_RD0070_30_89_20190408_00131.jpg

Upclose view of a large rodent burrow. Spring 2019.

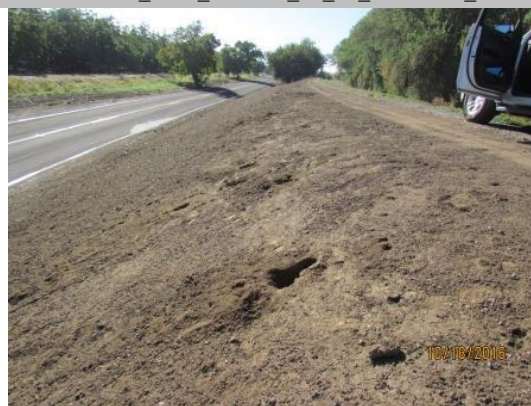
Photo 1 of 1 : SP_2019_RD0070_30_61_20190326_00009.jpg

LM Start	9.28	Rating **	M	Issue No.	61
LM End	9.28	Issue Type +	Ma	Location *	LS
Category	Earthen Levee			GPS Latitude/Longitude	
				Start	End
Item	Animal Control			39.107285 °	39.107285 °
				-121.900753 °	-121.900753 °
DWR ID	DWR_RD0070_02_f_2016_61				
Comment Code					
A3 : No rodents visible, but rodent burrows visible; need to backfill and compact or grout burrows.					
Inspector Comment

View of the rodent holes along the landside slope.

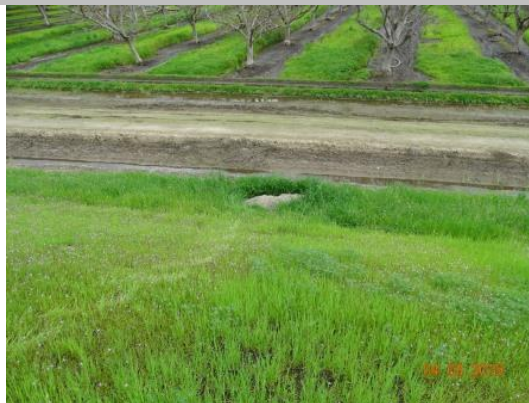
Photo 1 of 1 : SP_2019_RD0070_30_79_20190408_00125.jpg

LM Start	10.30	Rating **	U	Issue No.	79
LM End	10.30	Issue Type +	Ma	Location *	LS
Category	Earthen Levee			GPS Latitude/Longitude	
				Start	End
Item	Animal Control			39.095102 °	39.095102 °
				-121.892786 °	-121.892786 °
DWR ID	DWR_RD0070_02_s_2019_79				
Comment Code					
A3 : No rodents visible, but rodent burrows visible; need to backfill and compact or grout burrows.					
Inspector Comment

View of the rodent burrow at the landside toe. Spring 2019.

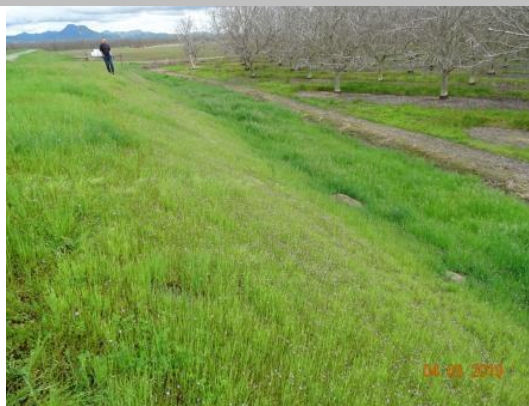
Photo 1 of 1 : SP_2019_RD0070_30_78_20190408_00124.jpg

LM Start	10.71	Rating **	U	Issue No.	78
LM End	10.71	Issue Type +	Ma	Location *	LS
Category	Earthen Levee			GPS Latitude/Longitude	
				Start	End
Item	Animal Control			39.089312 °	39.089312 °
				-121.893624 °	-121.893624 °
DWR ID	DWR_RD0070_02_s_2019_78				
Comment Code					
A3 : No rodents visible, but rodent burrows visible; need to backfill and compact or grout burrows.					
Inspector Comment

View of the rodent burrows on the landside slope and toe. Spring 2019.

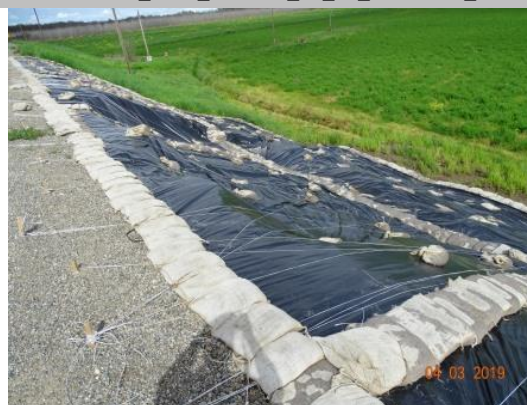
Photo 2 of 2 : SP_2019_RD0070_30_66_20190408_00118.jpg

LM Start	12.93	Rating **	U	Issue No.	66
LM End	13.03	Issue Type +	Ma	Location *	LS
Category	Earthen Levee			GPS Latitude/Longitude	
				Start	End
Item	Slope Stability			39.071323 °	39.070900 °
				-121.877606 °	-121.875728 °
DWR ID	DWR_RD0070_02_s_2019_66				
Comment Code					
S1 : Repair slope instability.					
Inspector Comment					
Sloughing on the landside slope occurred during the February 2019 storms. A temporary solution was used to address the issue. Permanent repairs should be completed to stabilize the slope.

View of the temporary solution used to address the sloughing. April 3, 2019.

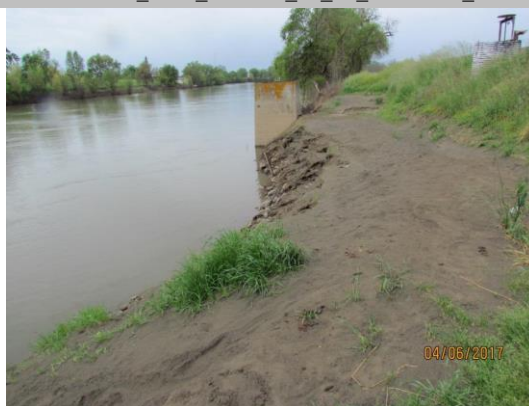
Photo 1 of 1 : SP_2019_RD0070_30_72_20190326_00012.jpg

LM Start	13.82	Rating **	A/W	Issue No.	72
LM End	13.82	Issue Type +	Ma	Location *	WS
Category	Earthen Levee			GPS Latitude/Longitude	
				Start	End
Item	Erosion / Bank Caving			39.068370 °	39.068370 °
				-121.862763 °	-121.862763 °
DWR ID	DWR_RD0070_02_s_2017_72				
Comment Code					
E2 : Schedule repair of erosion site prior to the next inspection.					
Inspector Comment					
Repair the erosion along the waterside slope.

View of the erosion along the waterside slope.

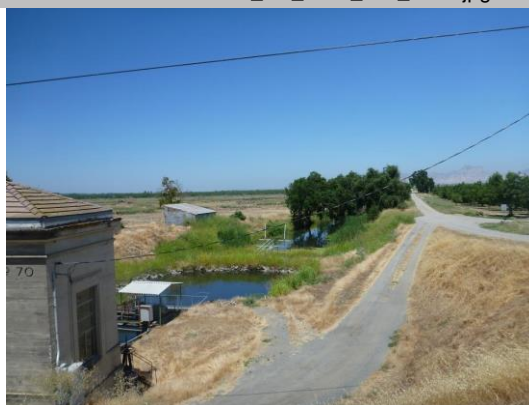
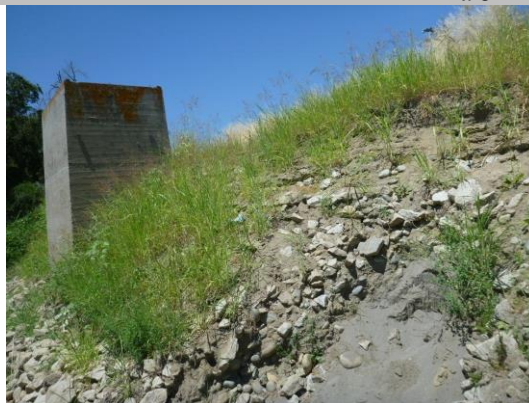
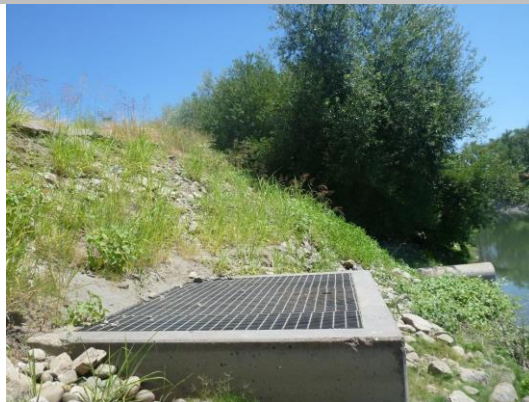
LM Start	13.83	Rating **	A/W	Issue No.	75	
LM End	13.83	Issue Type +	Ma	Location *		
Category	Supplemental			GPS Latitude/Longitude		
				Start		End
Item	2017 Storm Damage			39.068190	°	39.068190
				-121.862700	°	-121.862700
DWR ID	DWR_RD0070_02_f_2017_75					
Comment Code						
Inspector Comment						
Levee Evaluation Comments						
Description:						
Site ID No:152						
Site Designation:RD 70-01						
Repair Type: Erosion						
Rating:Area of Concern						
Field Date:7/17/2017						
Notes: bank slope erosion around a drainage pipe/box

LM Start	13.83	Rating **	A/W	Issue No.	75 (cont)	
LM End	13.83	Issue Type +	Ma	Location *		
Category	Supplemental			GPS Latitude/Longitude		
				Start	End	
Item	2017 Storm Damage			39.068190 °	39.068190 °	
				-121.862700 °	-121.862700 °	
DWR ID	DWR_RD0070_02_f_2017_75					
Comment Code						
Inspector Comment						
Levee Evaluation Comments						
Description:						
Site ID No:152						
Site Designation:RD 70-01						
Repair Type: Erosion						
Rating:Area of Concern						
Field Date:7/17/2017						
Notes: bank slope erosion around a drainage pipe/box
